## Evolution of the Flathead Compiled by Fred Mills

Here is the 221-239-255 cube U.S.A. flathead block story with pictures, to the best of my knowledge and ability to collect pictures so far.

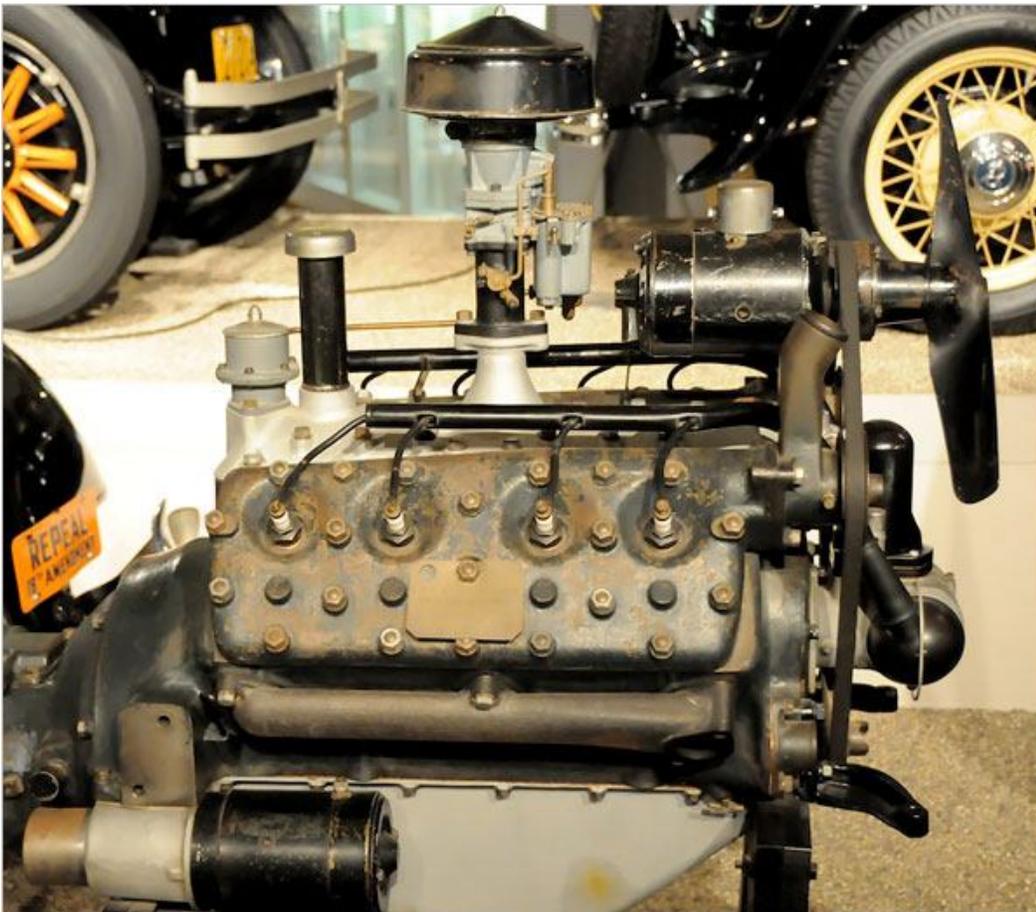
In the beginning of this story it is 1931 and Chevrolet had a 6 cylinder car. Henry Ford had to upstage them. Henry had a crash program going to develop an 8 cylinder motor, but it was not developed enough to put in production. Henry gave the order to start production of the improved 4 cylinder car for 1932, the model B. Apparently as Henry walked past the newly started production line turning out the shiny new 1932 4 cylinder Fords he made the decision to shut the line down and introduce the V8! Ford dealers were without cars for months. Ford Motor Company knew the first V8s were so bad that the first 1500 were not allowed to be sold to the public, they were for static display only and were supposed to be returned to Ford for engine swaps before being sold. And so, into the turbulent under developed world of prototype motors, the V8 Ford was introduced. The number of production changes to engine design in 1932 was phenomenal. A proper discussion of all the changes to 1932 Ford V8 motors can be found in David Rehor's 1932 Ford book. And so, if you visit the Henry Ford Museum you can see production V8 number 1, 18-1 itself. This engine was actually prototype motor number 243, but they had to start somewhere. The very early 32 motors feature some unique features, such as bolt on steady rod brackets and a block mounted dip stick. These features can be seen in this picture of 18-1:

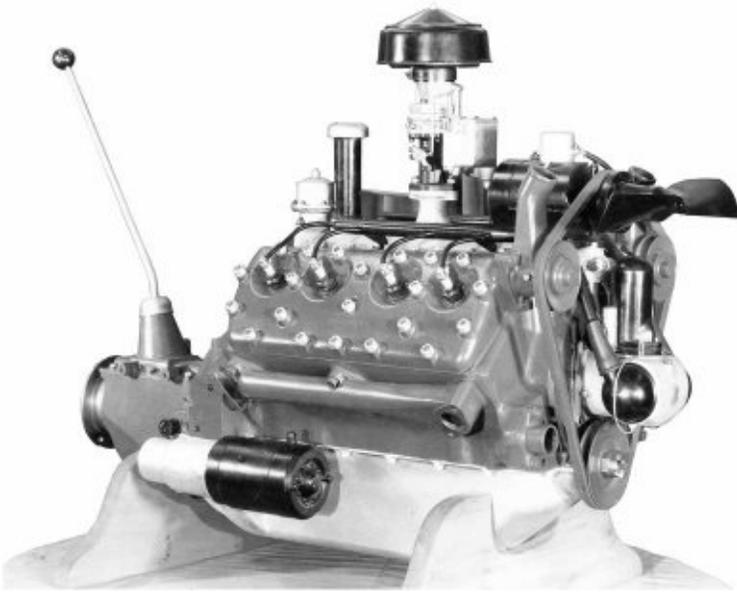
and on this picture of a very early production engine:

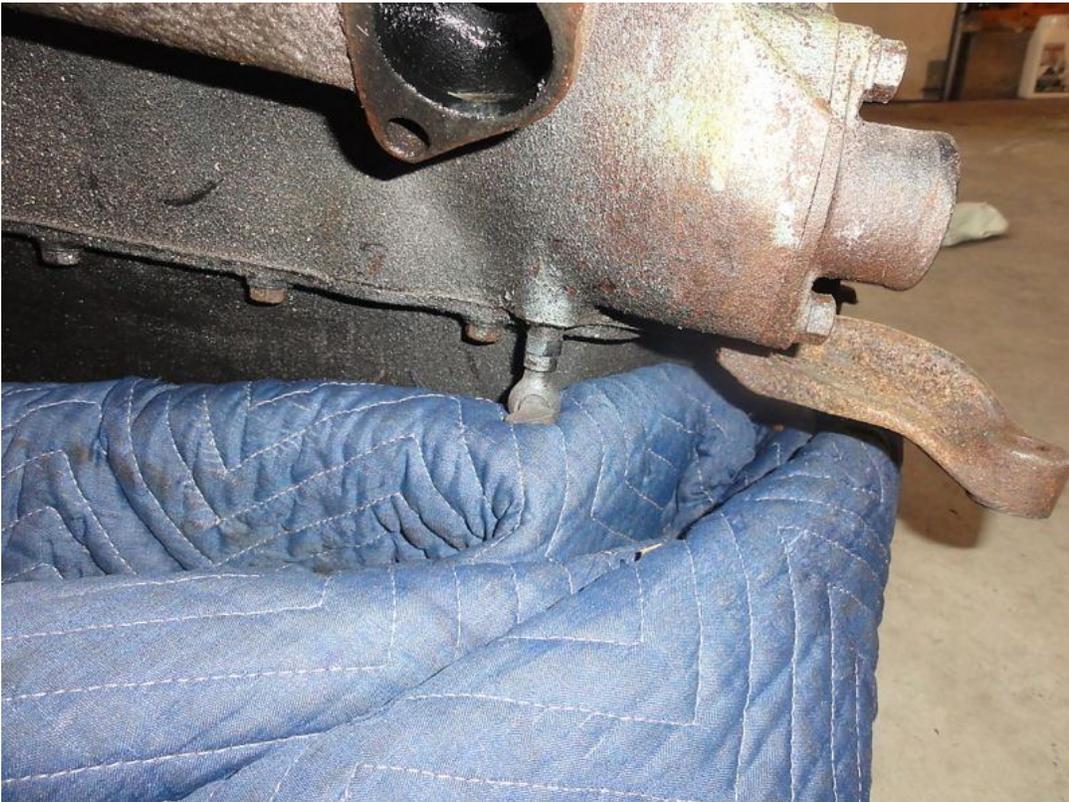
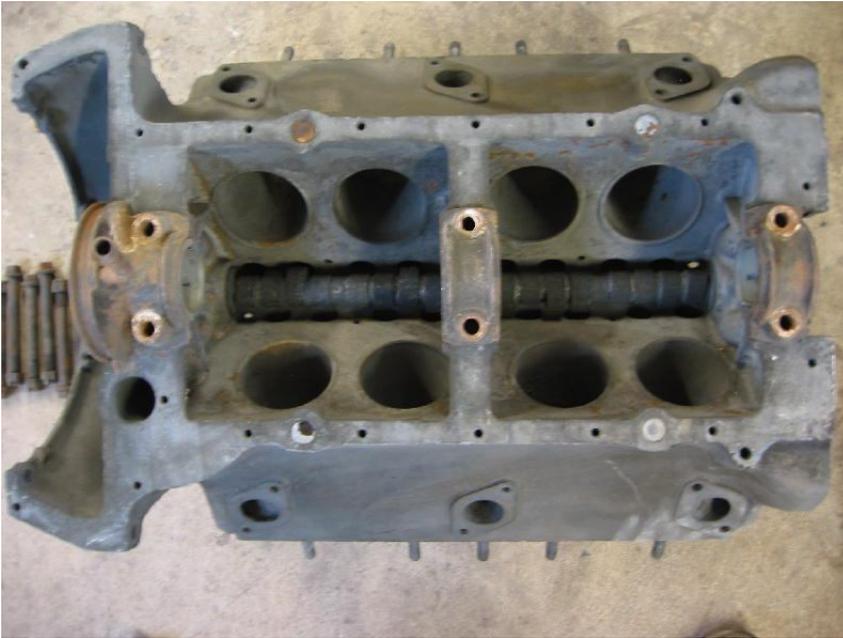
Early in production the oil dip stick was relocated to the oil pan and the block castings were changed to locate the steady rods in the bell housing casting. The 1932 V8 engines features a  $3 \frac{1}{16}$  bore by a  $3 \frac{3}{4}$  stroke for 221 cubic inches. The main bearings were 2.000 inches and the rod bearings were 2.000 inches. There was no provision for crankcase ventilation. There are 21 studs per head. The oil pan rail had four core plugs, two per side. The block featured drain petcocks pointed straight down at the front. The vertical drain petcocks and a bulge in the pan rail for a freeze plug can be seen in the following pictures:

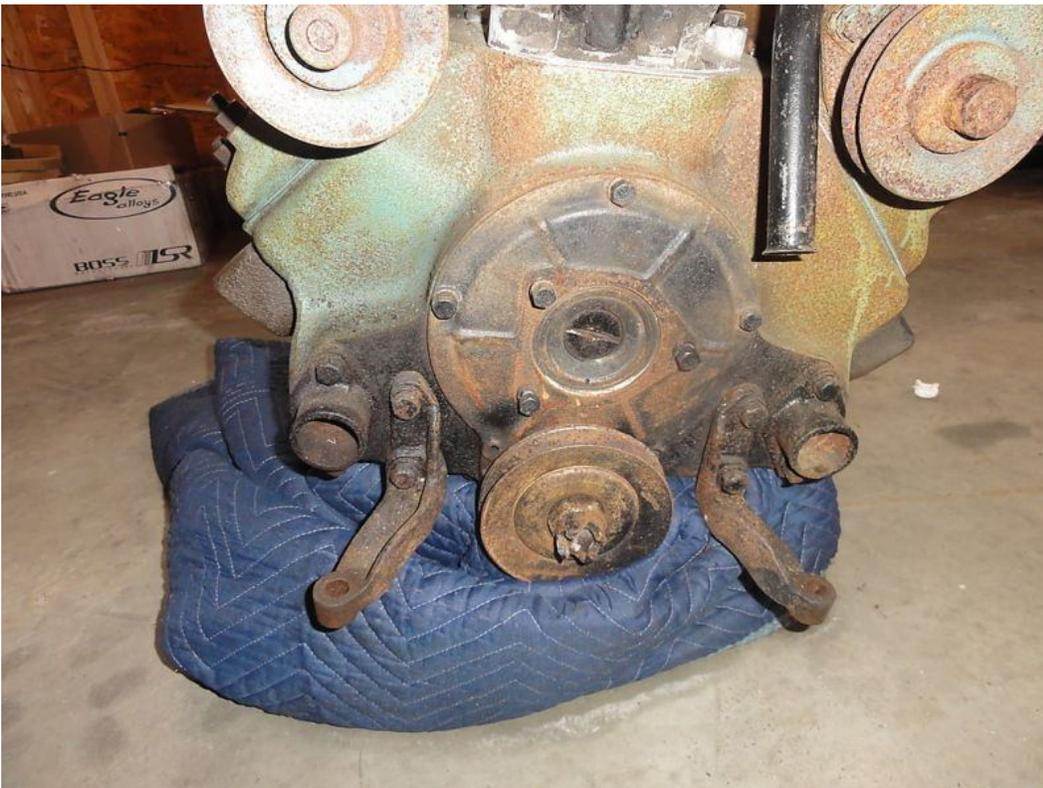
The front motor mounts bolted to brackets on either side of the timing cover. Interestingly these bolt holes were still drilled and tapped on all other American built flatheads. They continued to be used through 1936 for motor mounts, then they were not used again until 1953 trucks! The front of the block in 1932 was flat between the water inlets and the timing cover. The crankshaft were forged in 1932, the only 221-239-255 cranks to be forged, and they featured a very short snout. The snout was just long enough to hold the timing gear, crank pulley, and its retaining nut. This short crank snout was continued to the end of 1938 engine production. The 1932 motor mounts, flat block, and short crank can be seen in this picture:

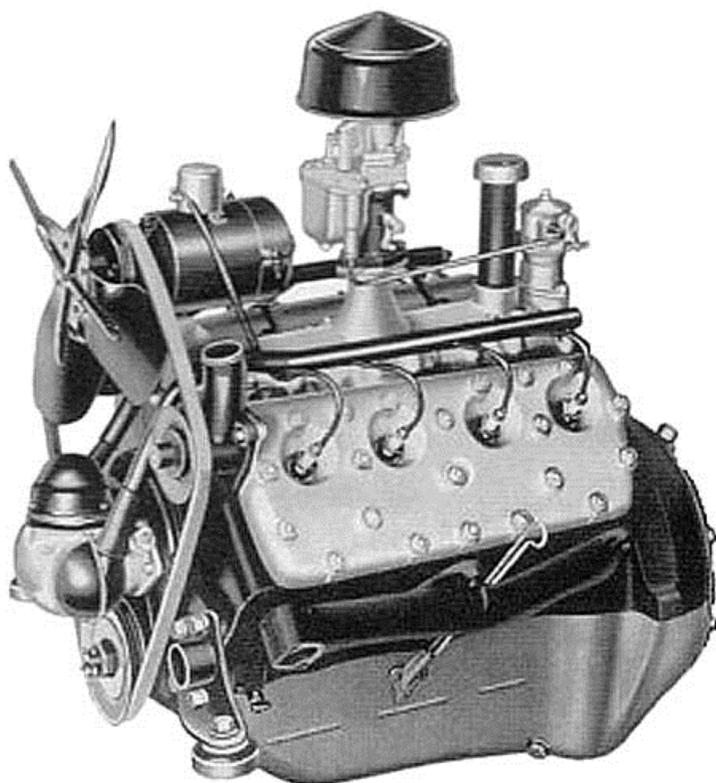
This is a correct assembled 1933 Ford V8.

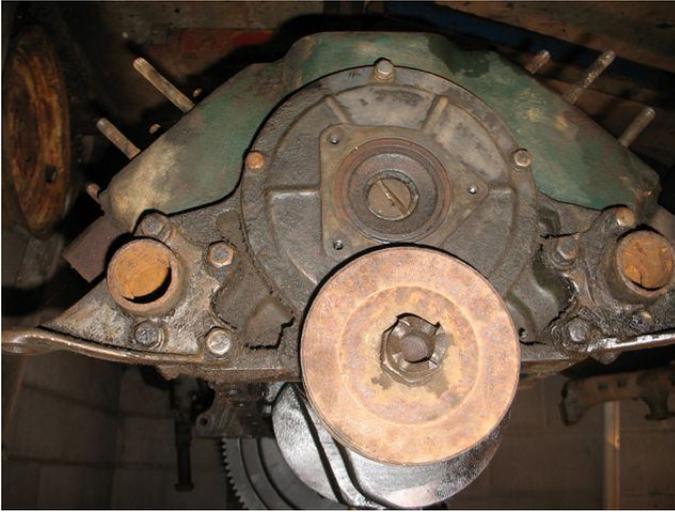
The recesses between the water inlets can be seen on the front of the block in this picture. The recesses in the 1933 blocks are the same depth on both sides of the timing cover. This engine has a forged crankshaft. The engine was upside down when this picture was taken and I flipped the picture over.

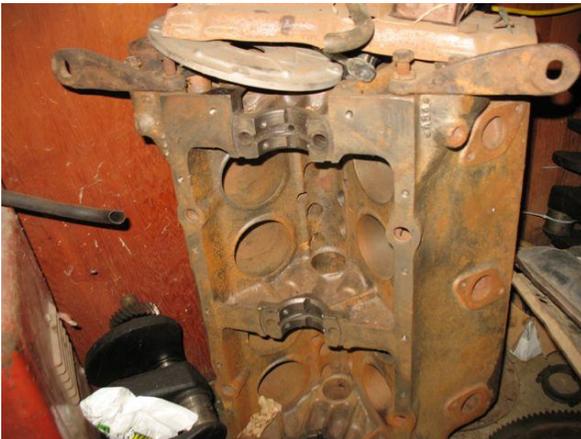
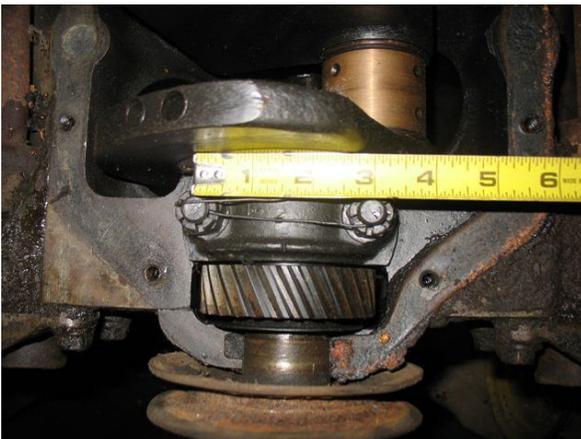
This is the crankcase area of a 1933 block. Note the four core plugs in the oil pan rail and the area to the passenger side of the front main bearing as it lacks the opening for crankcase ventilation. The distance between the studs on the main caps will measure approximately 3 inches center to center, common to all poured bearing Ford V8 blocks.

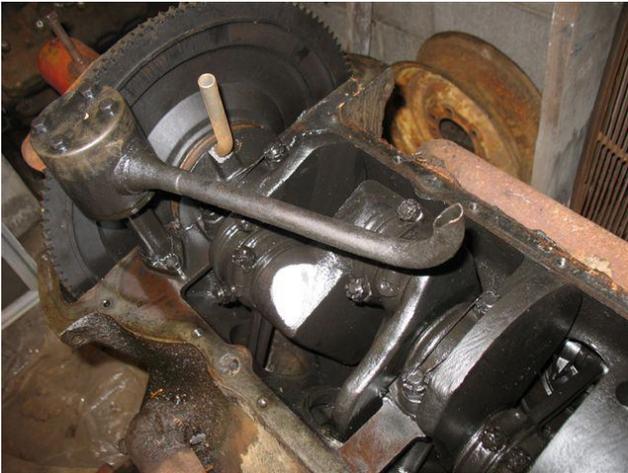
Here is the oil pump, rear main, and flywheel of the 1933 motor with the forged crankshaft.

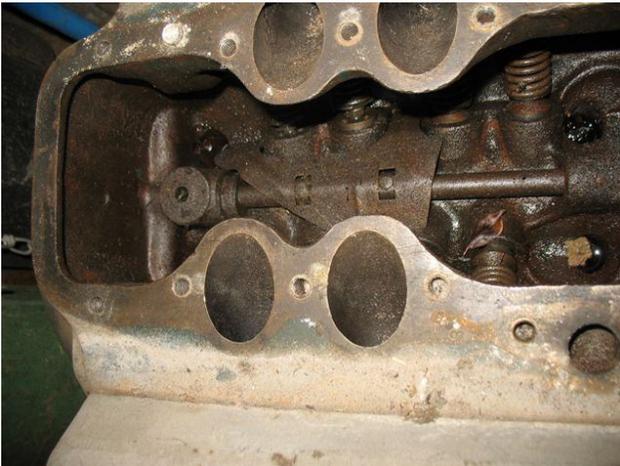
The fuel pump push rod area of the non-ventilated blocks looks like this.

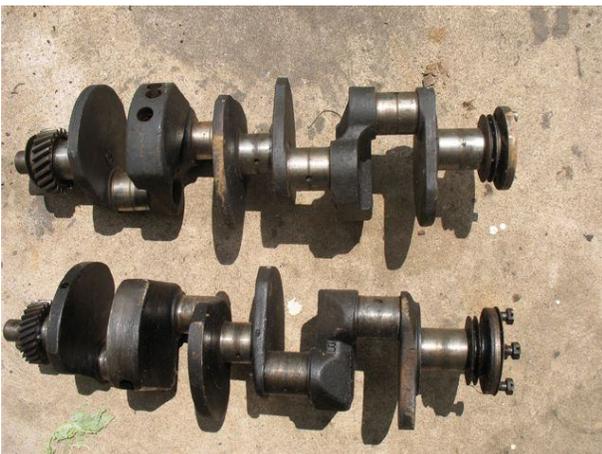
David J also provided pictures of both a forged crankshaft and a cast crankshaft. The forged crankshaft has a constant width #2 counterweight while the cast crankshaft has an extra bit of weight cast in that makes the counterweight thicker on the outer part, among other differences. The differences can be seen in these pictures. The forged crankshaft is on the left and cast crankshaft is on the right.

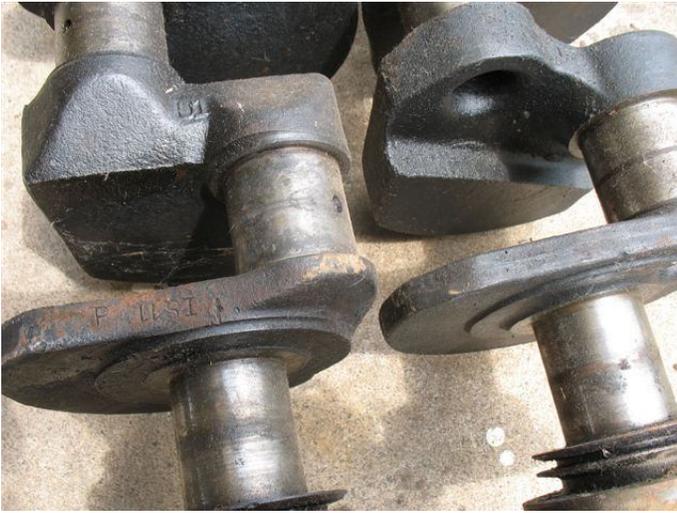
Here is a closer look at the rear of the crankshafts. Again, the forged is on the left.

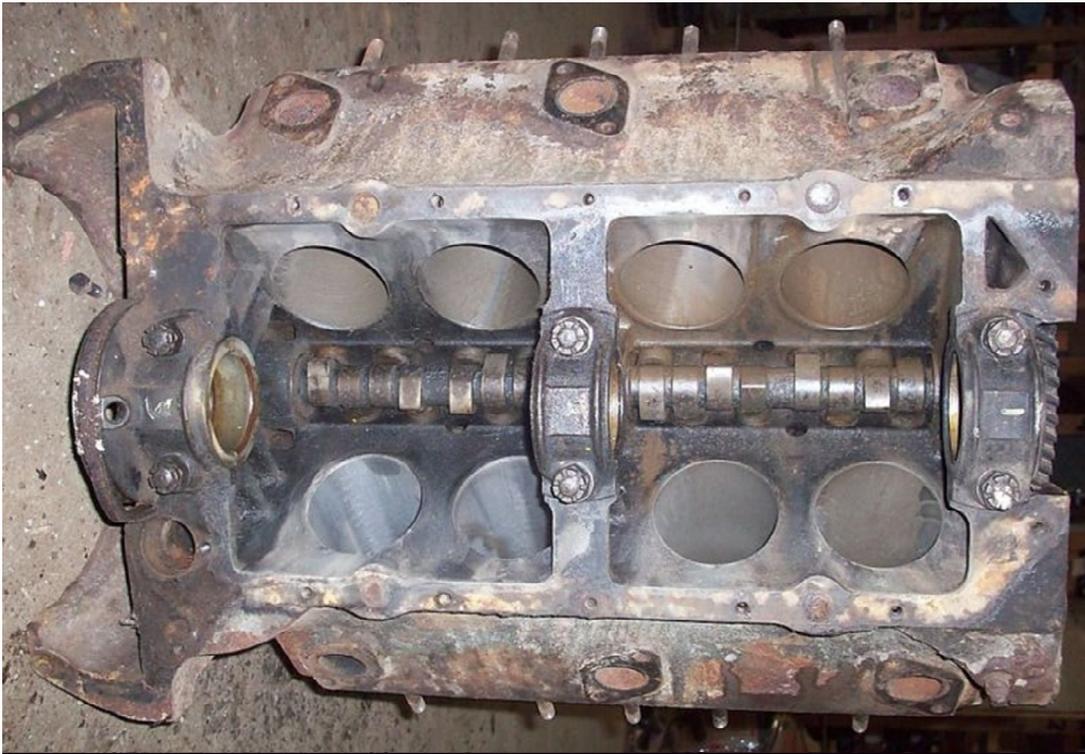
Here is the crankcase area. Notice the crankcase ventilation hole next to the front main bearing.

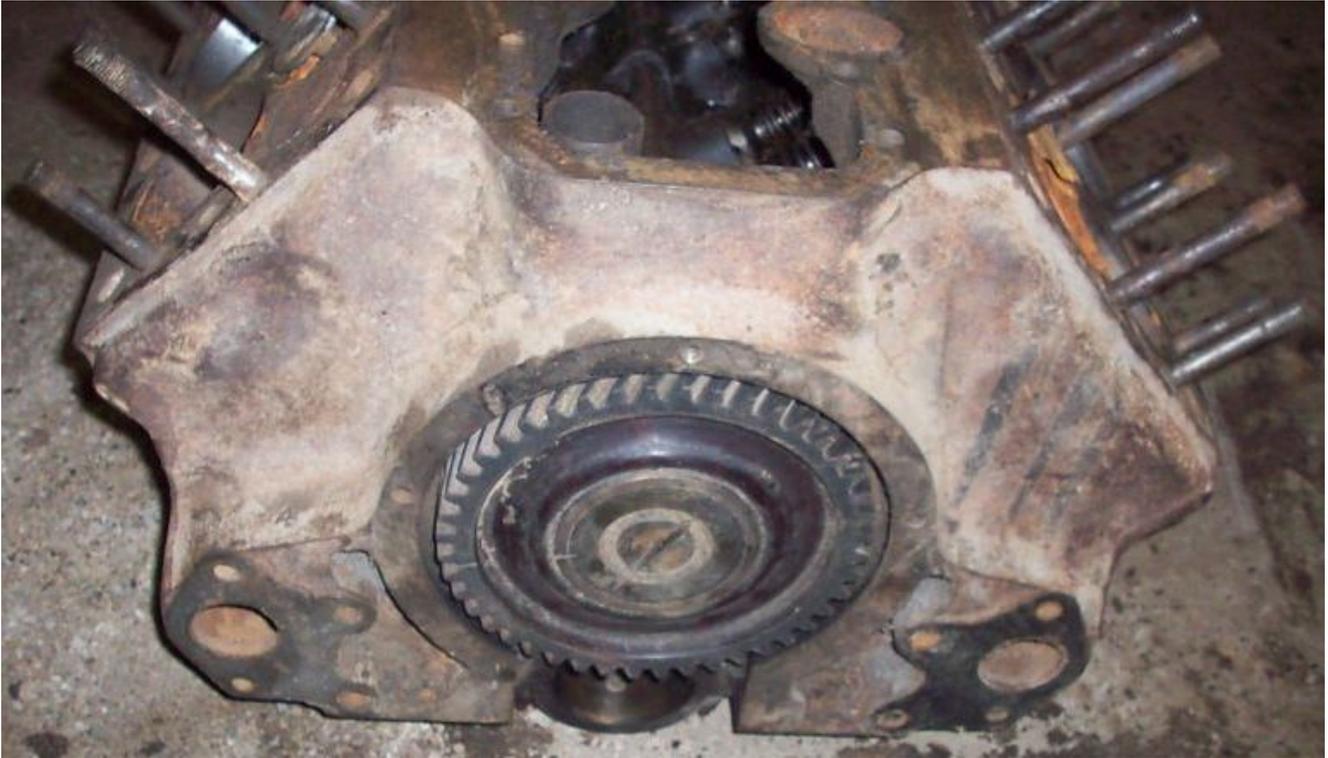
Here is the front of the block. Notice the depressions between the water inlets on each side of the timing cover. It is hard to see in this pictures, but the passenger side depression is shallower than the driver side depression.

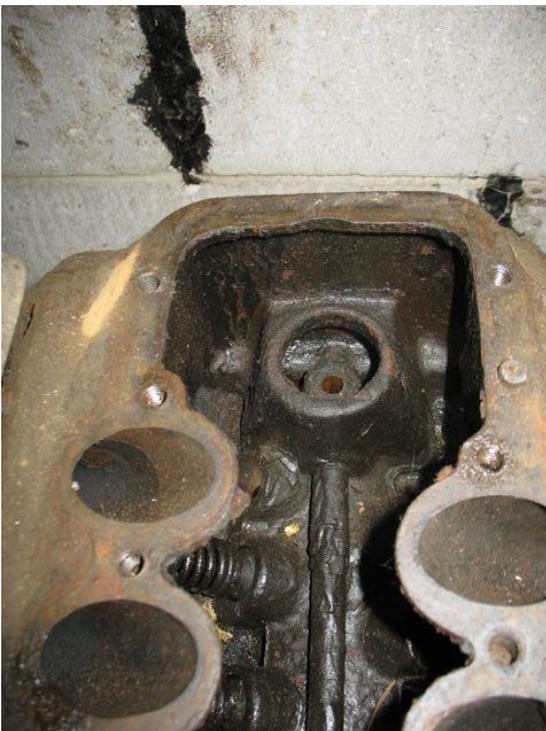
Another change to come with the crankcase ventilation was a cast in baffle in the fuel pump push rod area of the valley, as can be seen in this picture.

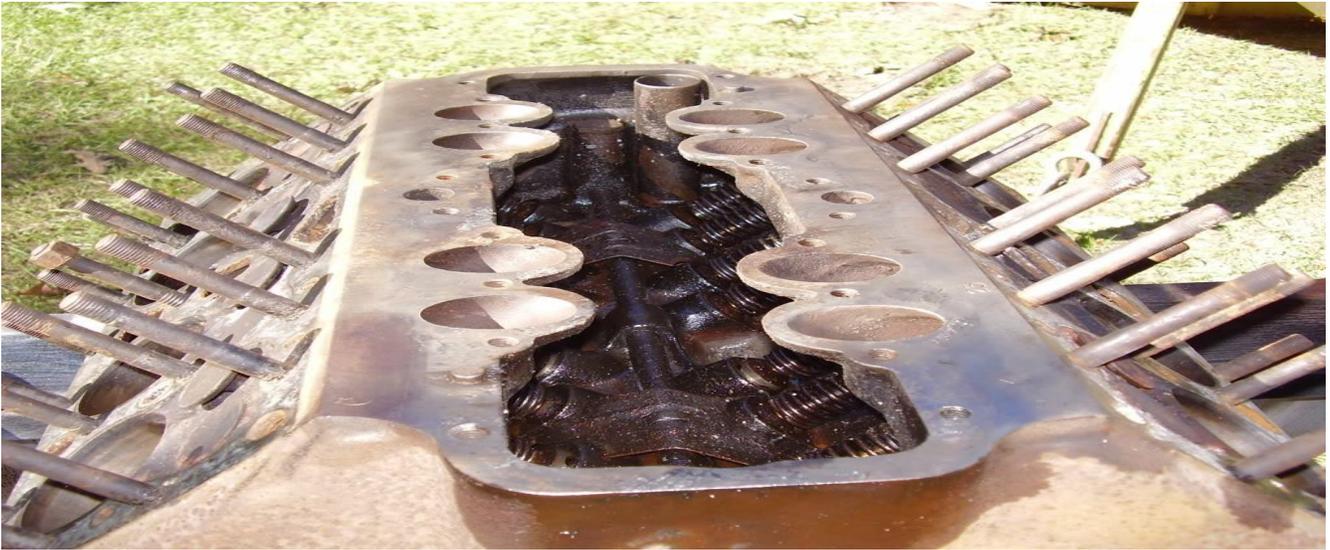
The noteworthy feature in this picture is the crankcase breather tube.

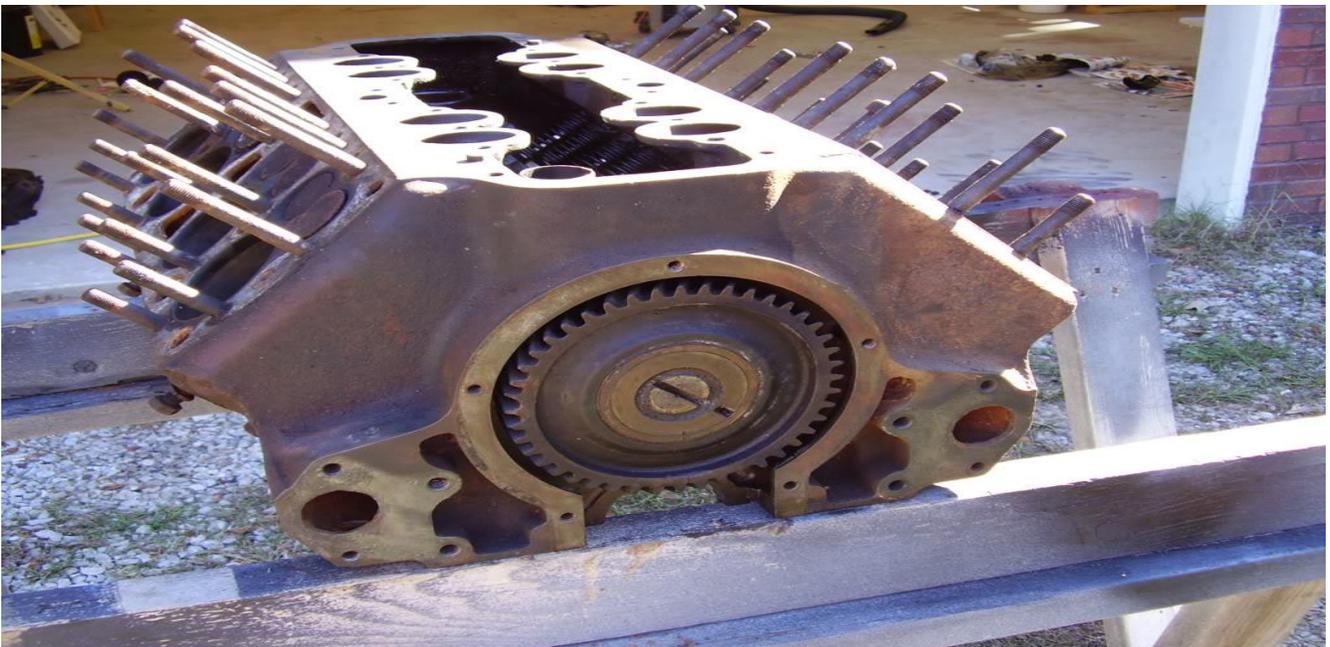
Here is the front of an insert motor. Notice how the exterior features are identical to the poured motor.

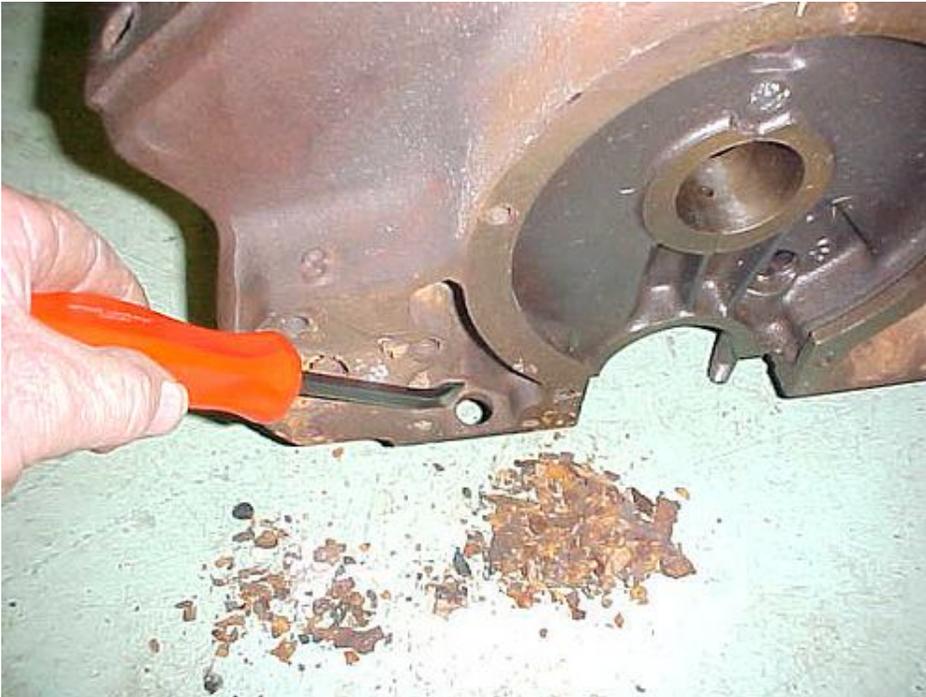
I have been told that Canadian blocks of this era feature this hole.

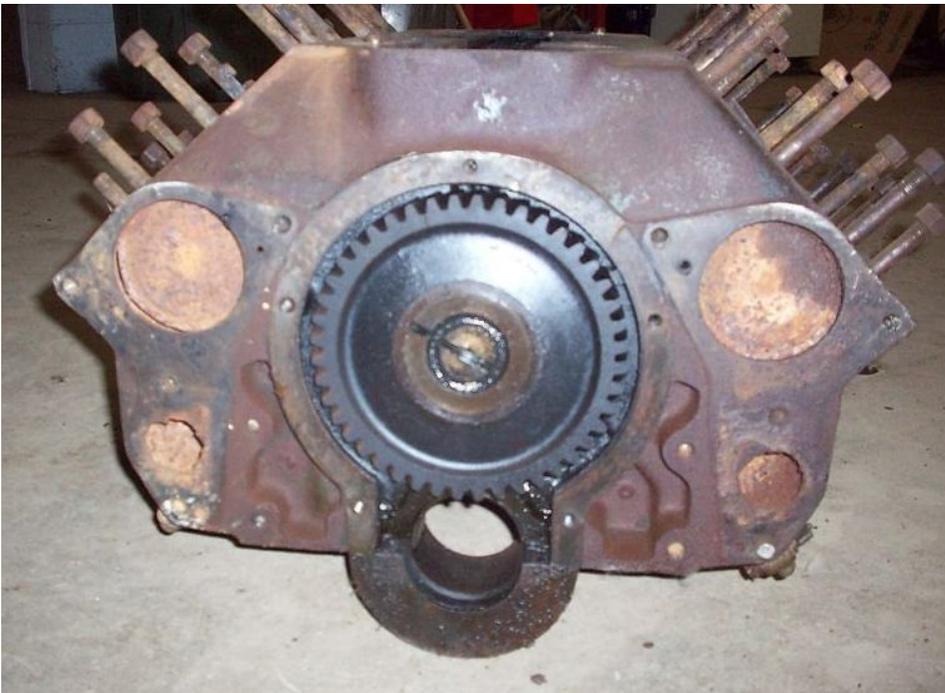
Here is the water pump mounting area on the front of the block.

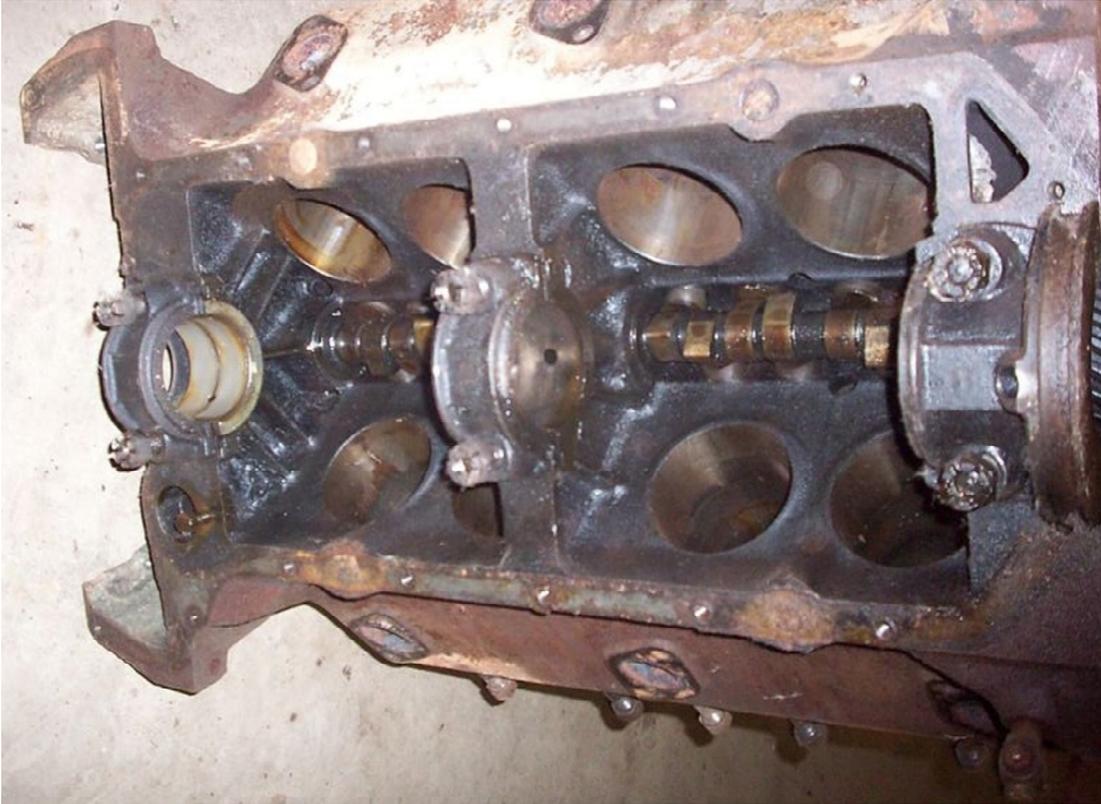
The crankcase area was mostly unchanged from the earlier insert bearing motors. The main bearing size remained 2.400 inches.

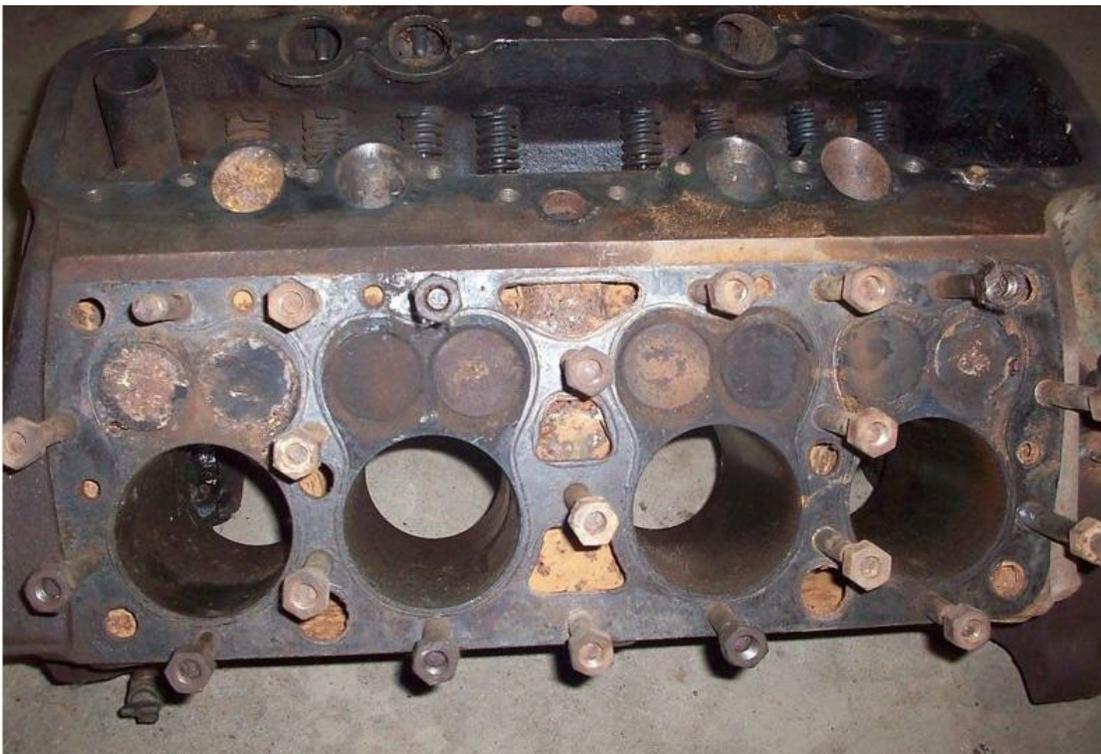
The cylinder head deck is pretty much identical to the earlier 21 stud blocks.

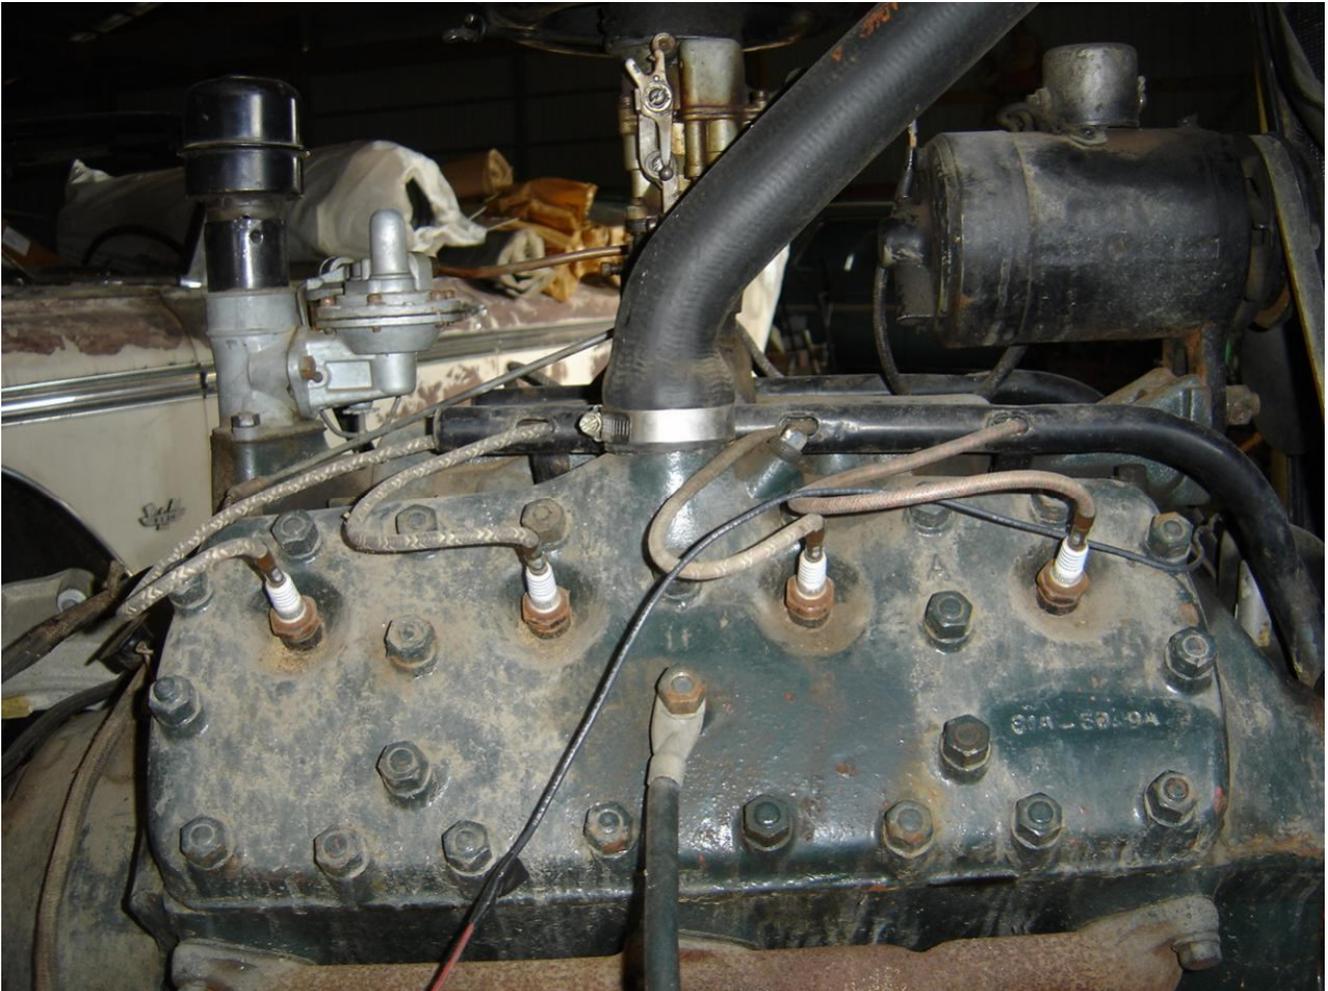
Here is a picture of a 1938 24 stud motor. The cylinder heads are one year only, featuring a cast in part number on the face of the heads. The battery cable is not supposed to attach to the middle head stud.

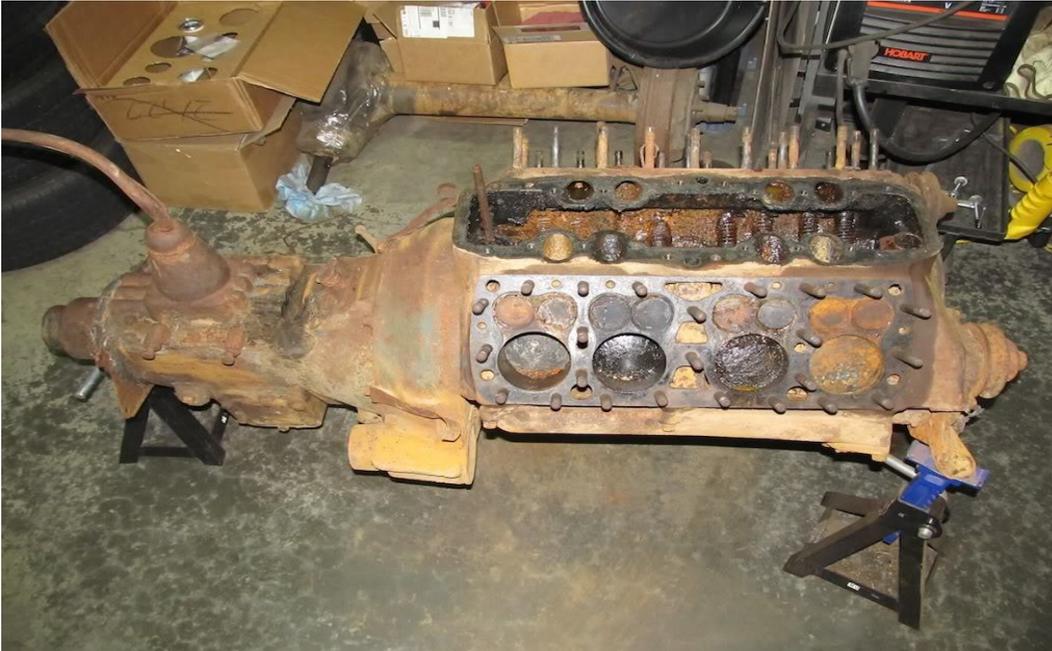
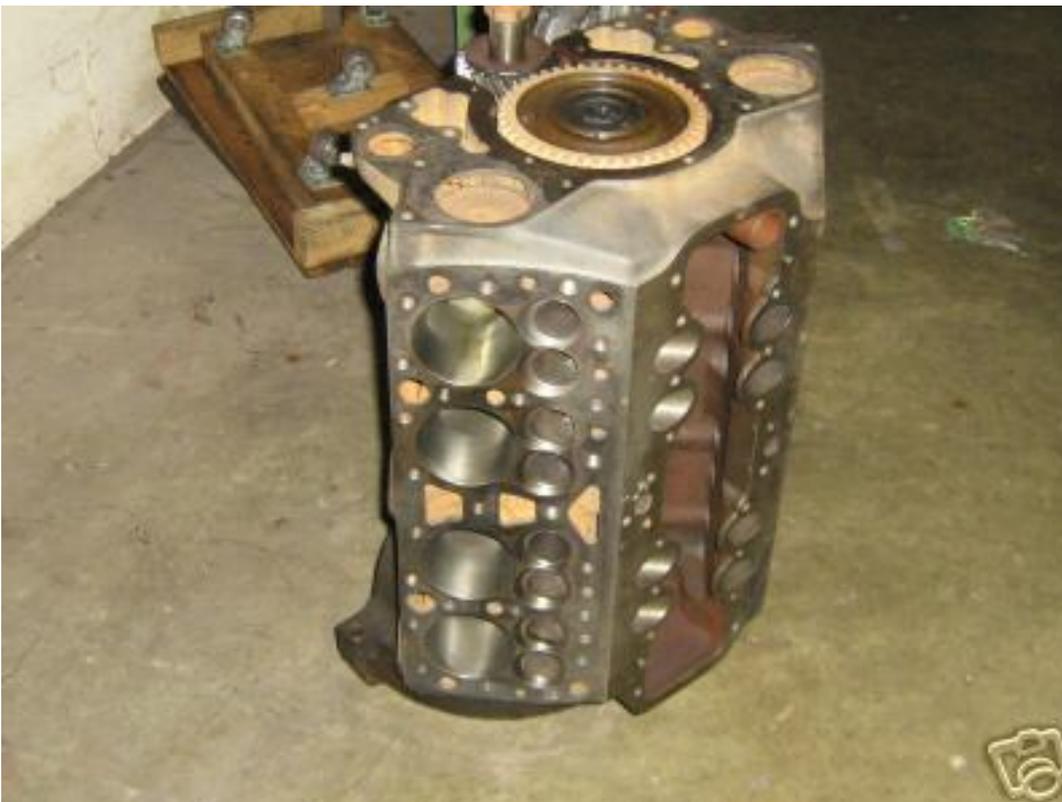
The deck and front of the block on the 221 cubic inch Ford motor is almost identical to the 1937-1938 21 stud motor, with the exception of 24 head studs. The water holes in the deck and other similarities can be seen the following two pictures. These blocks can be bored 1/8 over to 239 cubic inch size so a 3.1875 bore should not be used to determine block identity.

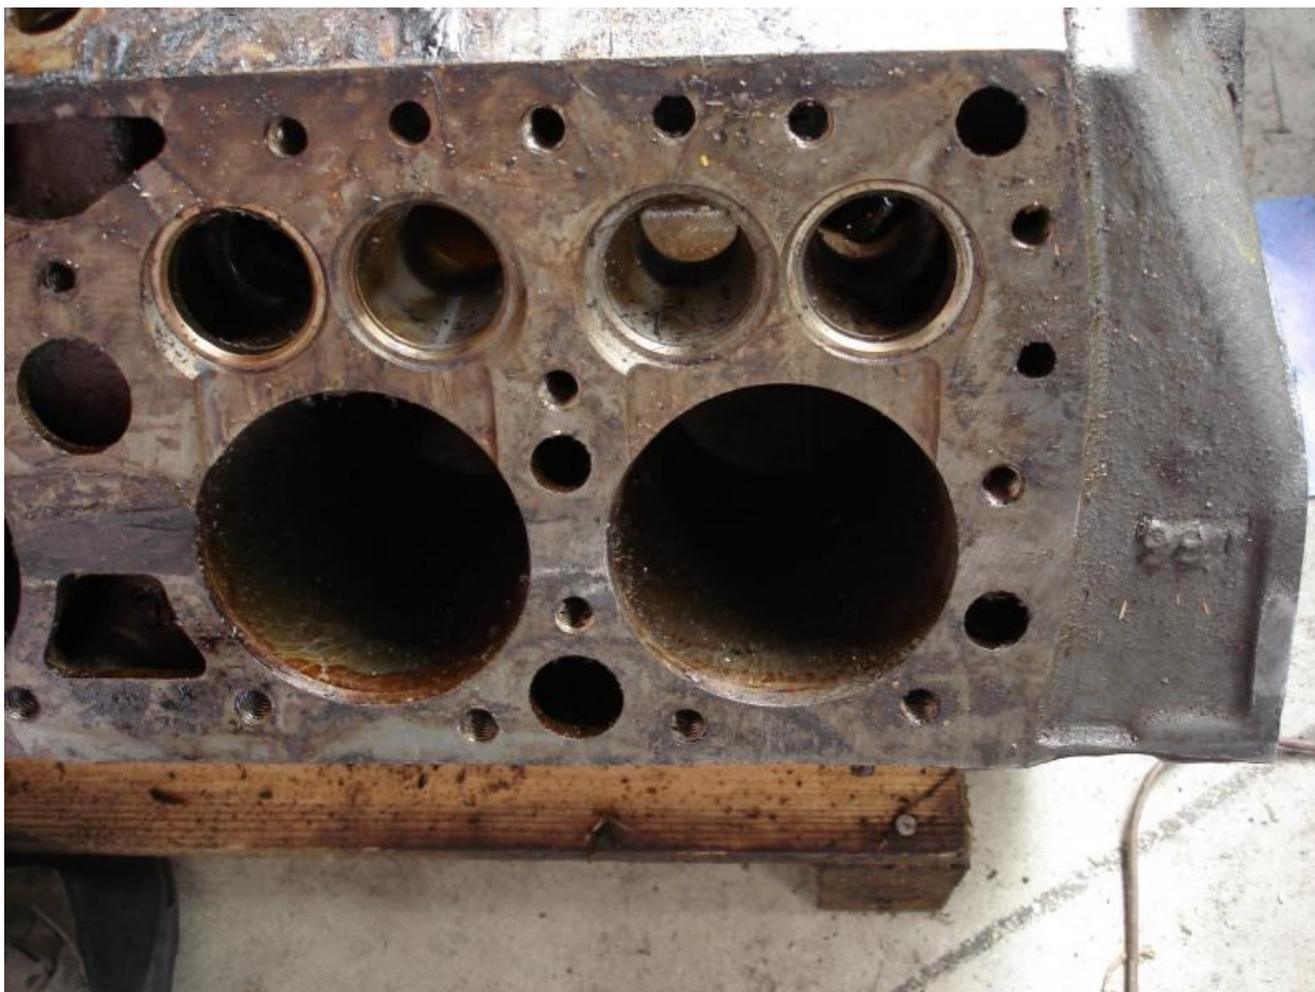
The 239 cubic inch Mercury engine was also optional in trucks. The water holes in the deck feature a circular center instead of the upside down keystone. Some 239 blocks had 99 stamped into the passenger side intake rail near the front, but not all. As with the LB, an unscrupulous person could have added this marking to a less desirable engine also. The determination on one of these blocks should be made using the center water holes in the deck. Mercury motors will have an upside down keystone at the bottom and a circular hole in the middle. These can be seen in the following picture. This is a factory relieved new old stock block owned by a Ford Barn member.

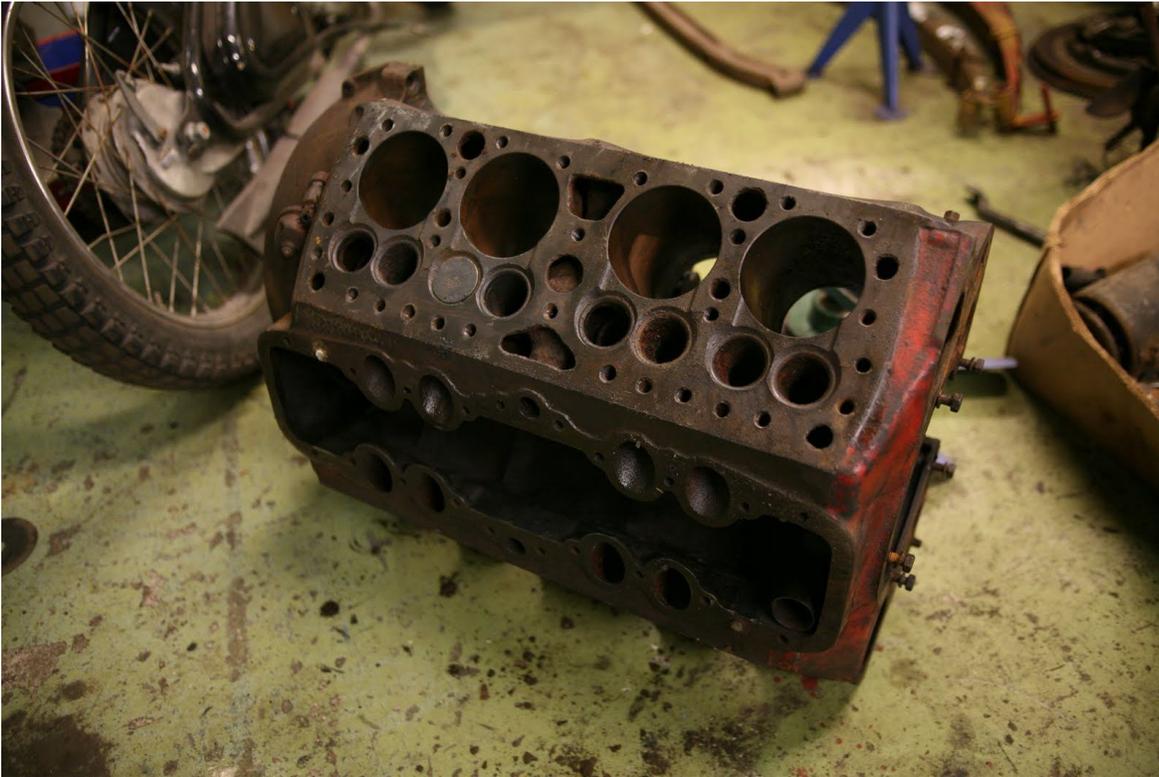
The curve in the outer block wall and the raised intake can be seen in this picture. Compare the block side in this picture to the block sides in the lower 1939 Ford block picture.

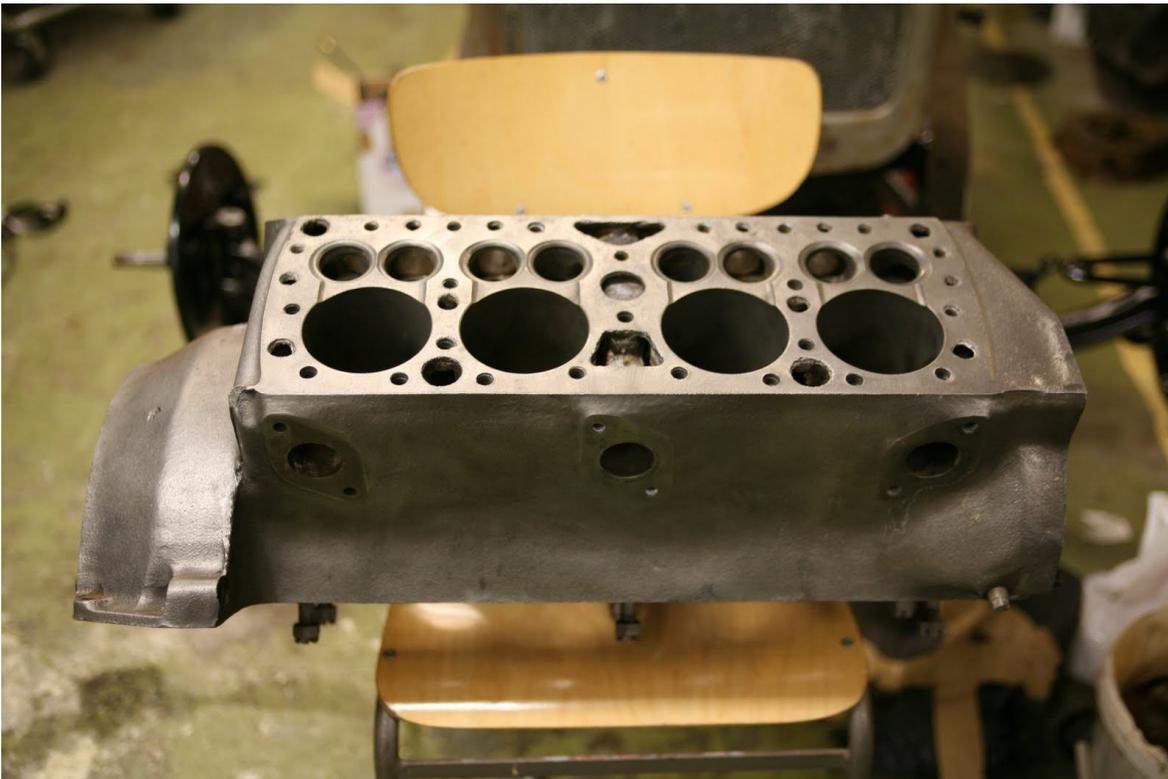
The flat oil pan rail without the bulges for core plugs can be seen in this picture.

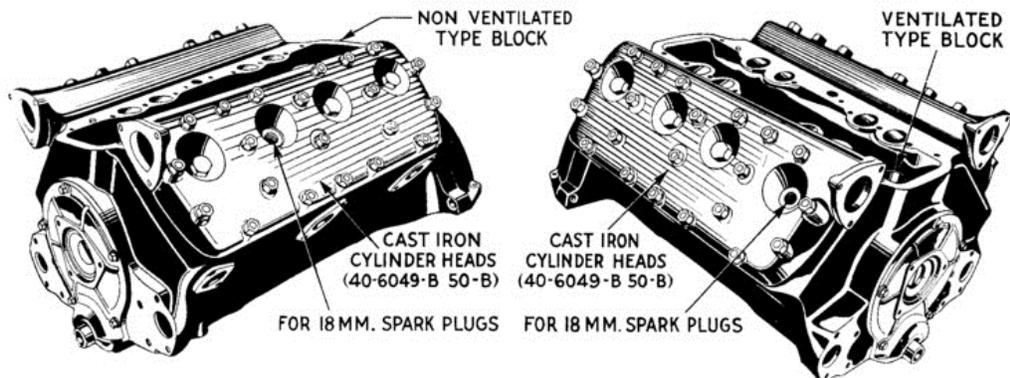
### V8 Block Chart 1932 to 36

18-6012-D—(FOR 1933, 1934 V-8 TRUCKS)

51-6012—(FOR 1935, 1936 TRUCKS)

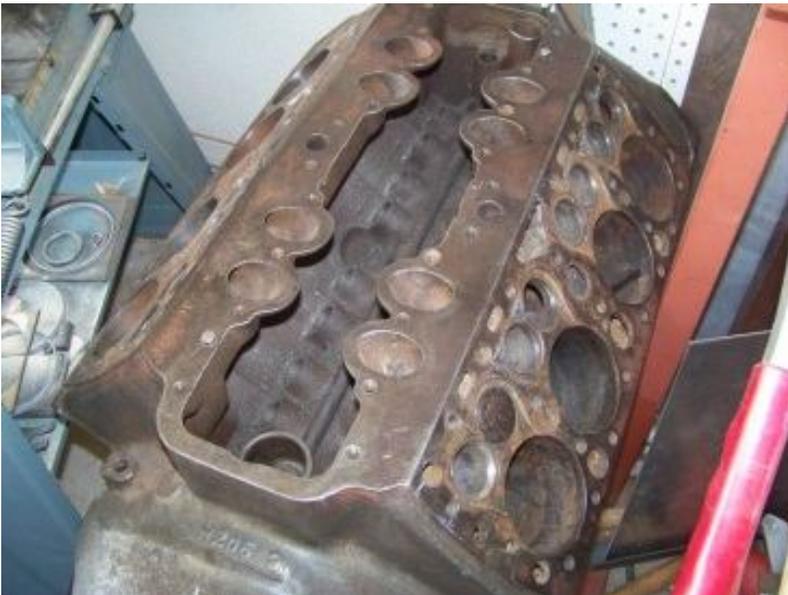
The intake rail is clearly flat again as can be seen in this picture. Someone has relieved this block around the valves following a head gasket as a guide.

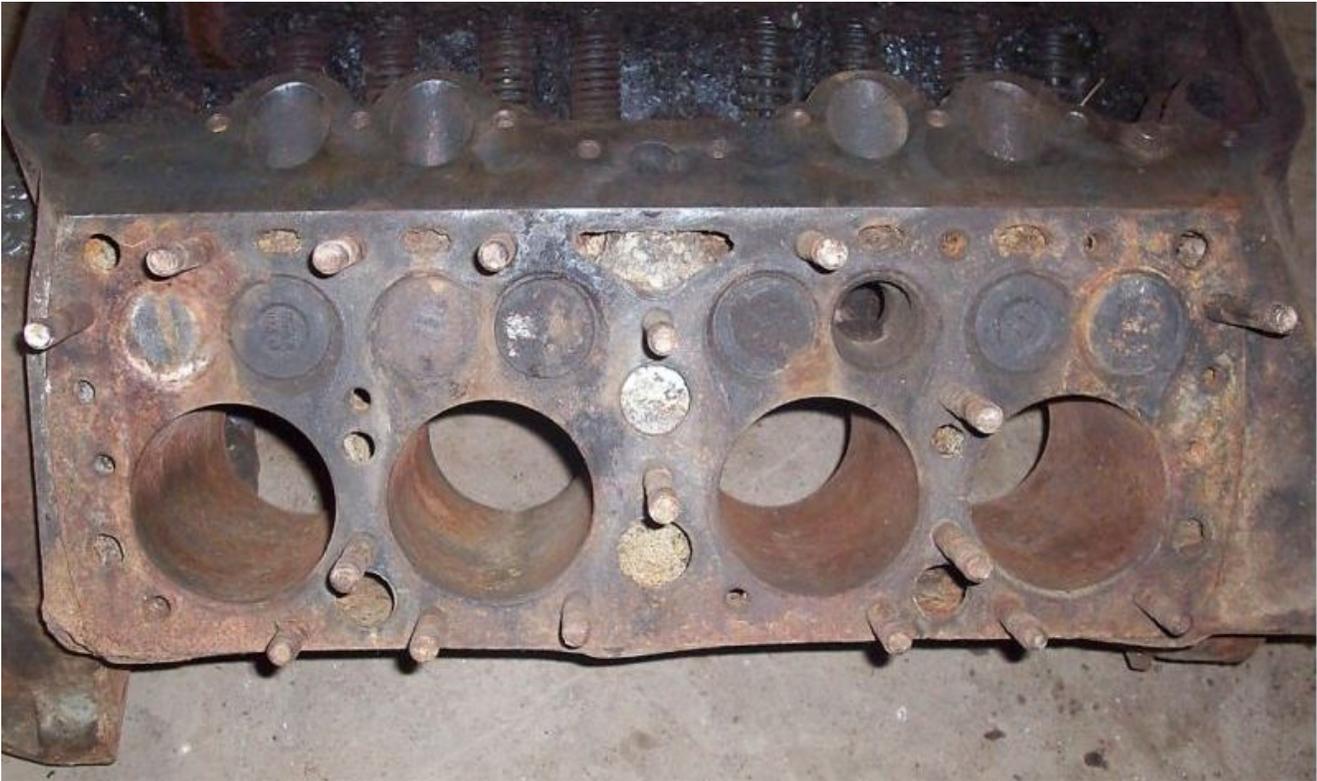
The circular water holes in the center of the cylinder head deck can clearly be seen in this picture.
