## Evolution of the Flathead Compiled by Fred Mills

Here is the 221-239-255 cube U.S.A. flathead block story with pictures, to the best of my knowledge and ability to collect pictures so far.

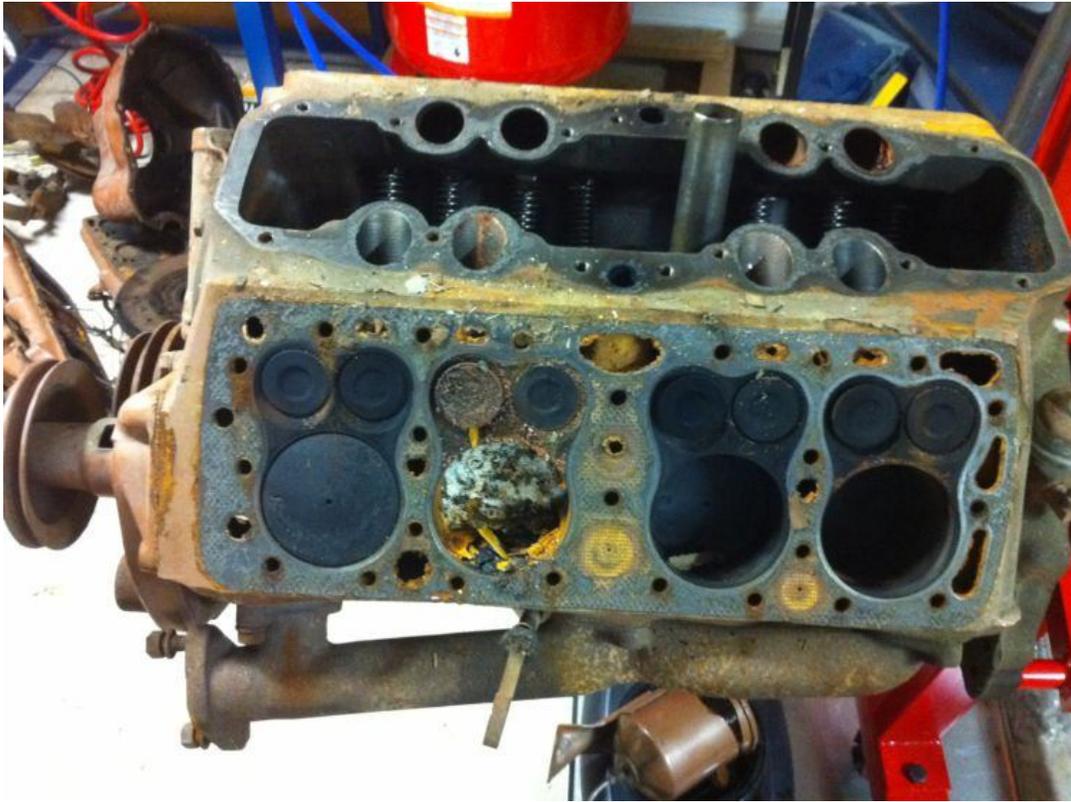
The revised cooling passage at the rear of the cylinder head deck can be seen in this picture.

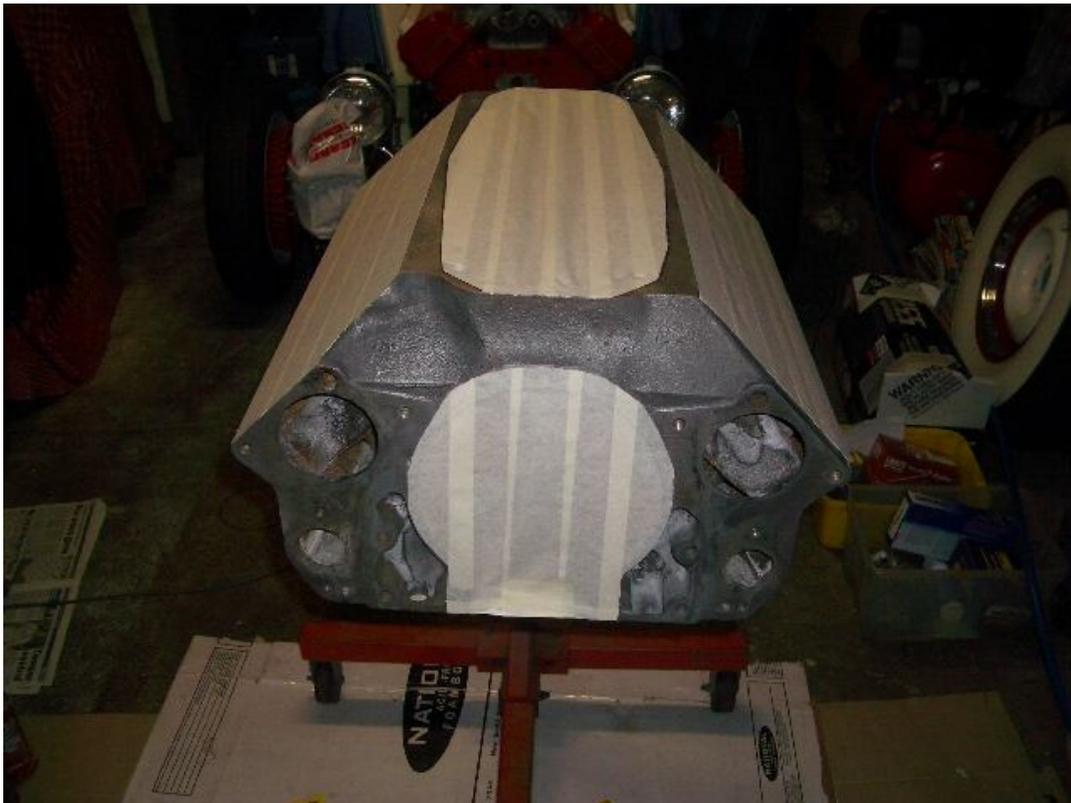
The added cooling passage at the top of the water pump can be seen in this picture.
